STURGEON POOL DAM

**ULSTER COUNTY, NEW YORK
INVENTORY NUMBER NY 75**

PHASE 1

INSPECTION REPORT

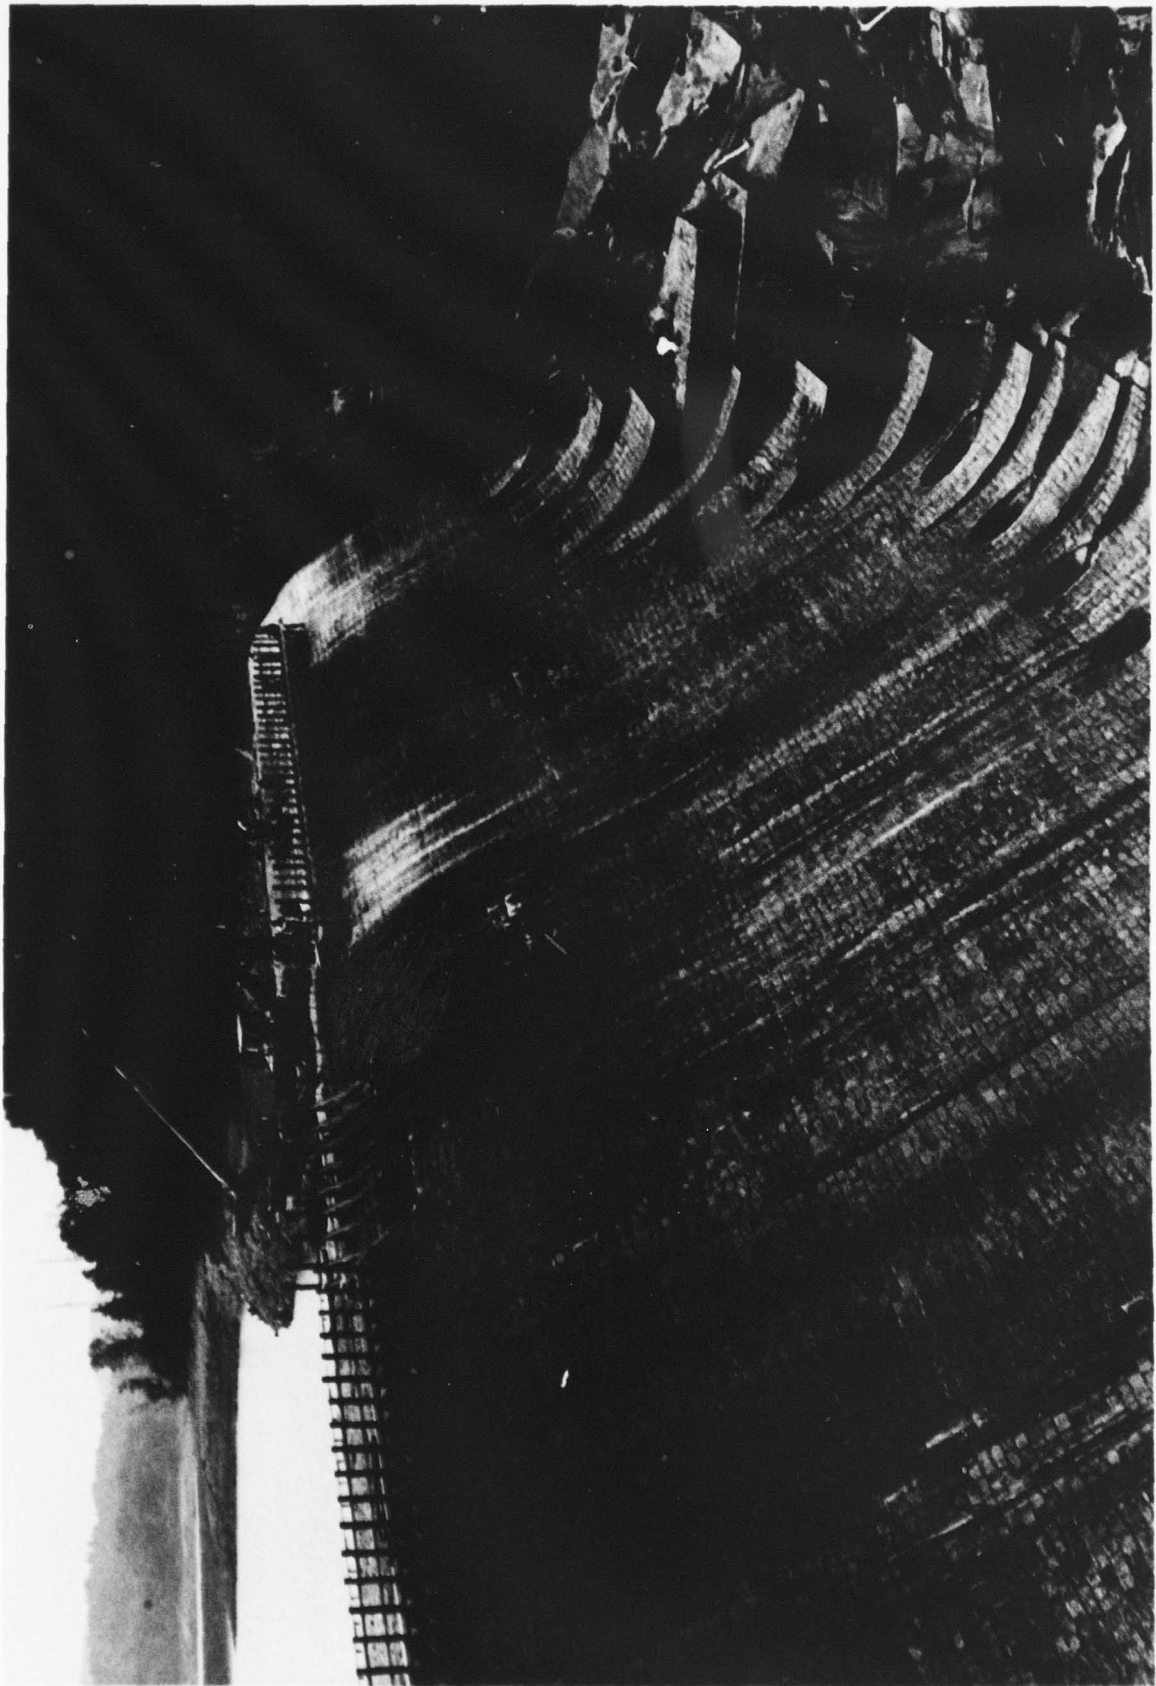
OVERVIEW OF DOWNSTREAM
FROM RIGHT ABUTMENT
